# Floor Marking Tape Case Study

## Heavy Duty Floor Marking Tape Pays For Itself In Three Months, Proves That Using A More Durable Floor Marking Material Saves Labor Costs For Manufacturing Companies

Stop-painting.com helps create more cost effective industrial floor marking systems with its patent pending Superior Mark™ floor tape.

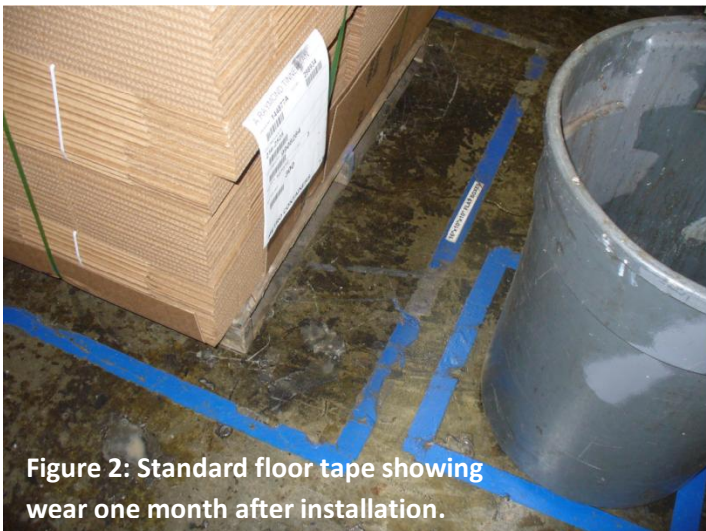
Figure 2: Standard floor tape showing wear one month after installation.

The industrial engineer found that when subjected to the everyday wear and tear that included pallet dragging and forklift traffic, standard vinyl tape would last about one month before it needed complete replacement.

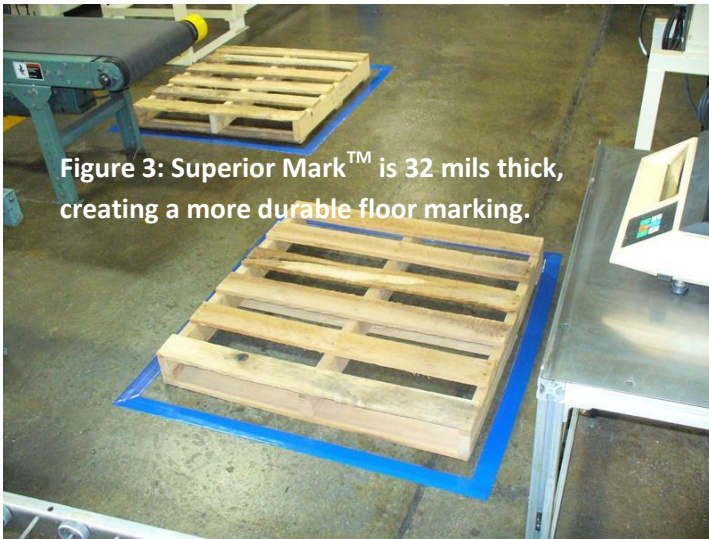
Figure 3: Superior Mark™ is 32 mils thick, creating a more durable floor marking.

Of the total 385 feet of Superior Mark™, less than 20 linear feet needed to be replaced over the same seven month period.

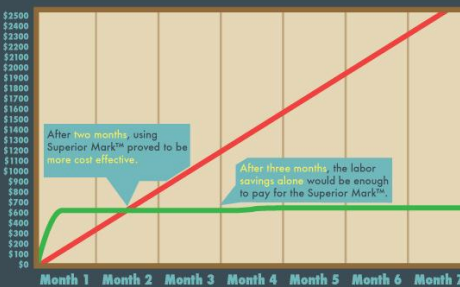
## TOTAL COST

**SUPERIOR MARK™** ■  
**COMPETITOR'S TAPE** ■

**COMPETITOR'S TAPE \$2482.55**  
**SUPERIOR MARK™ \$689.71** → **SAVES \$1793**

Based on the average labor rate, over the seven month case study, it would cost \$1,792.84 more to keep the floor marked with standard floor tape compared to Superior Mark™. Although the cost of the tape itself was higher for Superior Mark™ (\$344.25 compared to \$134.75 for the standard tape), because the standard tape had to be replaced monthly, the cost of the labor made standard tape overall much more costly to use. After just two months, using Superior Mark™ proved to be more cost effective. After only three months, the labor savings would be enough to pay for the Superior Mark™.
